Physical Point Guarding at a Hydroelectric Facility

Project Scope

Machine Guard & Cover, Co. was tasked to design, manufacture and install physical point guarding at a hydroelectric power station after an employee was injured performing standard maintenance operations.

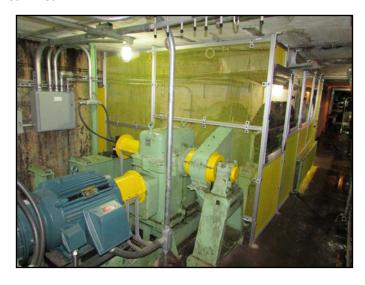
Where a simple point guard could not cover a very large gear, an area guard was used. This also had the benefit of keeping a narrow hallway from becoming even more confined.

Using a "gotcha stick" gap measuring device, the distance to hazards directly behind the mesh was measured. The size of the openings in the mesh combined with the distance to the hazard locations required additional point guarding for several locations.

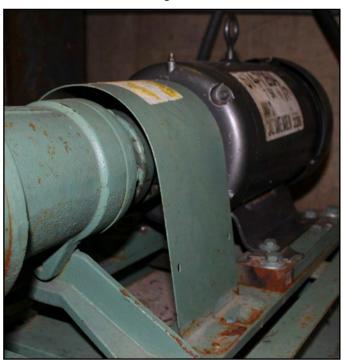
The coupling covers in the valve galleries at the hydroelectric facility were another location requiring physical point guarding. The pumps were using an older design of coupling cover guards that left wide gaps on each end of the bent sheet metal guard.

Using stock parts manufactured from 3/16" black ABS plastic, these locations were quickly and cost effectively updated to a newer design that eliminated gaps.
